**UNITED STATES  
NUCLEAR REGULATORY COMMISSION**  
REGION III  
2443 WARRENVILLE ROAD, SUITE 210  
LISLE, IL 60532-4352

EA-10-087

**SUBJECT: DAVIS-BESSE NUCLEAR POWER STATION SPECIAL INSPECTION TO  
REVIEW FLAWS IN THE CONTROL ROD DRIVE MECHANISM REACTOR  
VESSEL CLOSURE HEAD NOZZLE PENETRATIONS 05000346/2010-  
008(DRS) AND EXERCISE OF ENFORCEMENT DISCRETION**

Enclosure: Inspection Report 05000346/2010-008(DRS);  
w/Attachments: 1. Supplemental Information  
2. Chronology of Examinations  
3. Comparison of Examination Results  
4. Pictures- Examinations, Nozzle Repairs, and Flow Paths  
5. Davis-Besse Special Inspection Charter

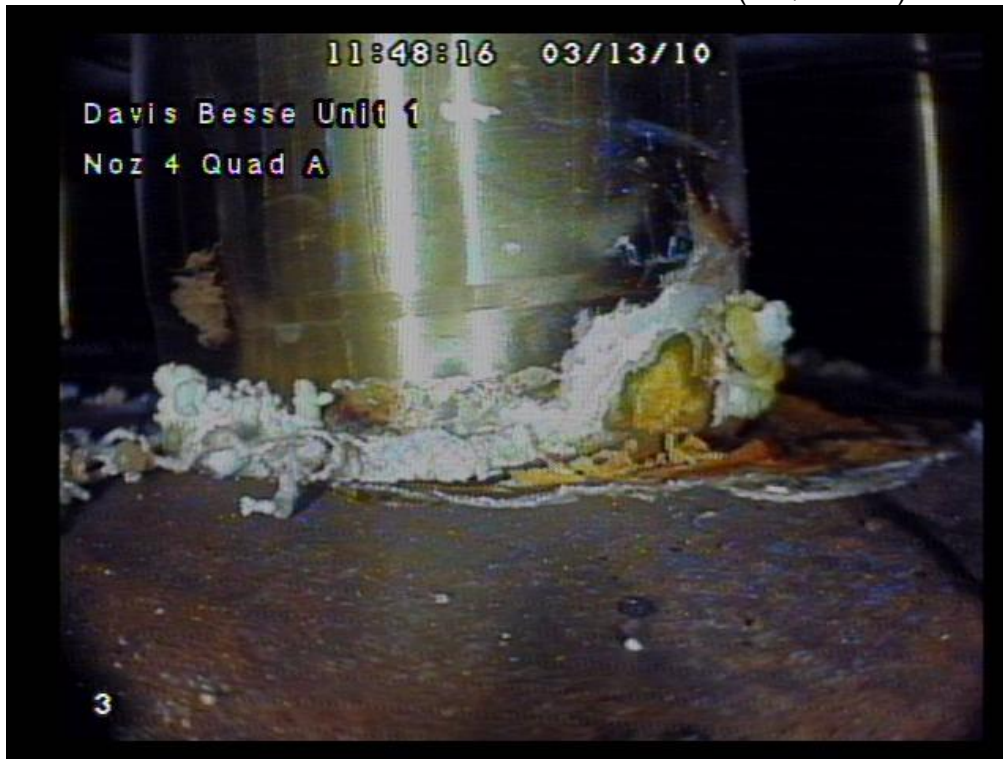
As a result of bare metal visual (BMV) examinations, the licensee-identified 14 CRDM nozzle locations with adherent boric acid deposits potentially indicative of leakage. Of these, only CRDM nozzle No. 4 was identified with "popcorn" shaped deposits characteristic of "active leakage."

Picture No. 1A - As-Found Bare Metal Visual – Nozzle 4 (A Quadrant)

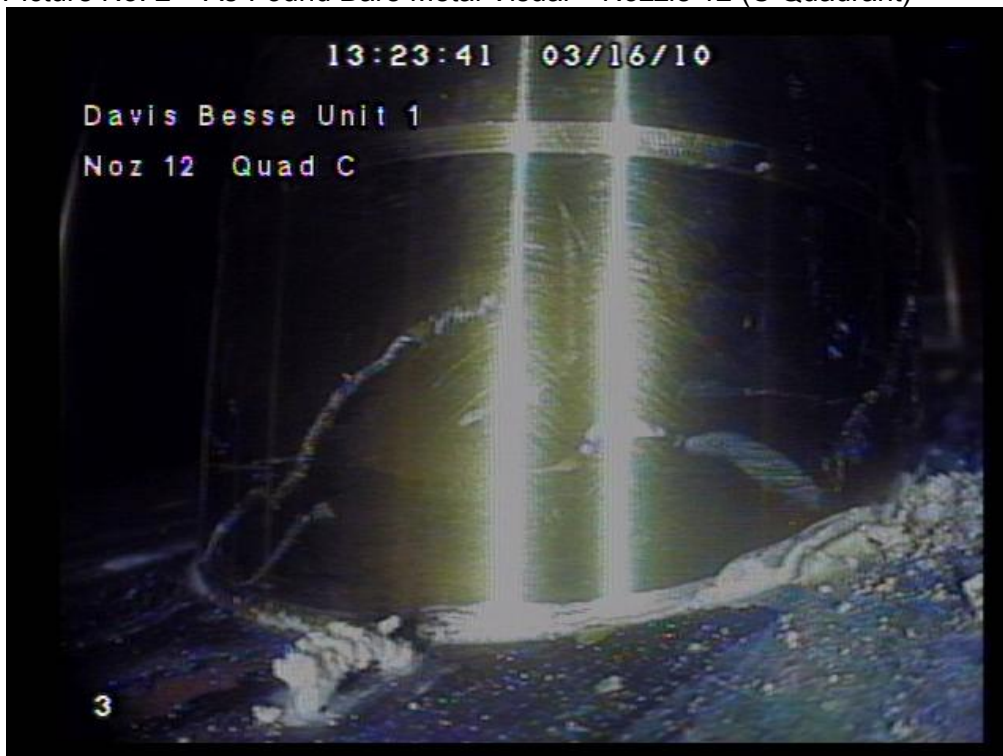
Picture No. 2 – As-Found Bare Metal Visual – Nozzle 12 (C Quadrant)

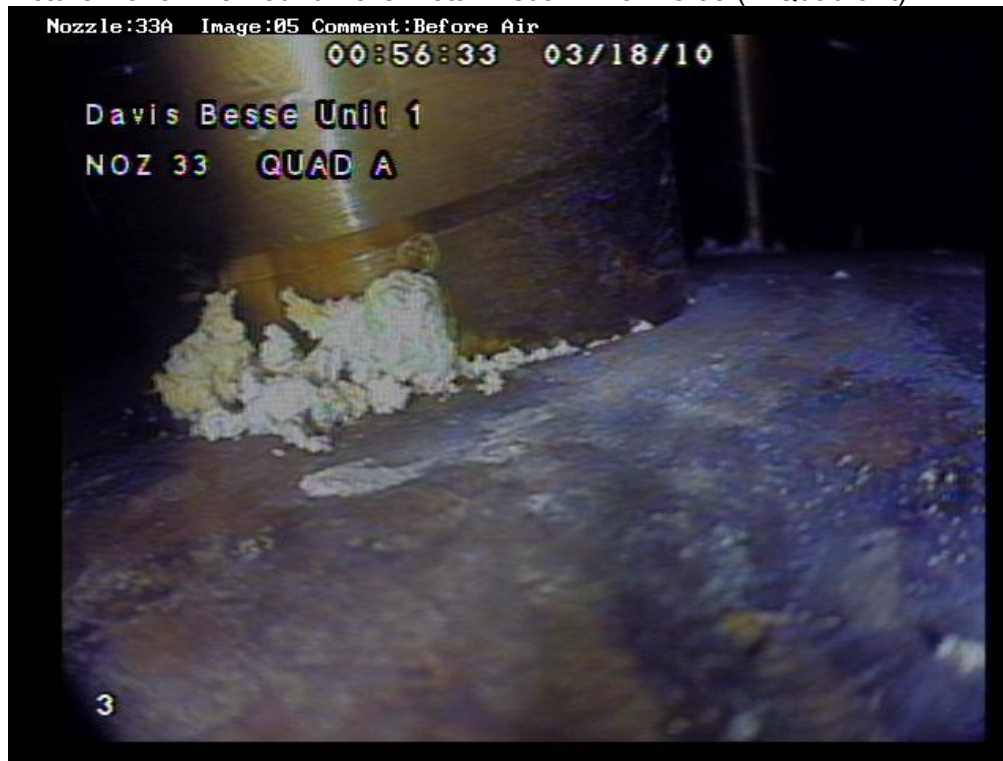
Picture No. 3 - As-Found Bare Metal Visual – Nozzle 33 (D Quadrant)

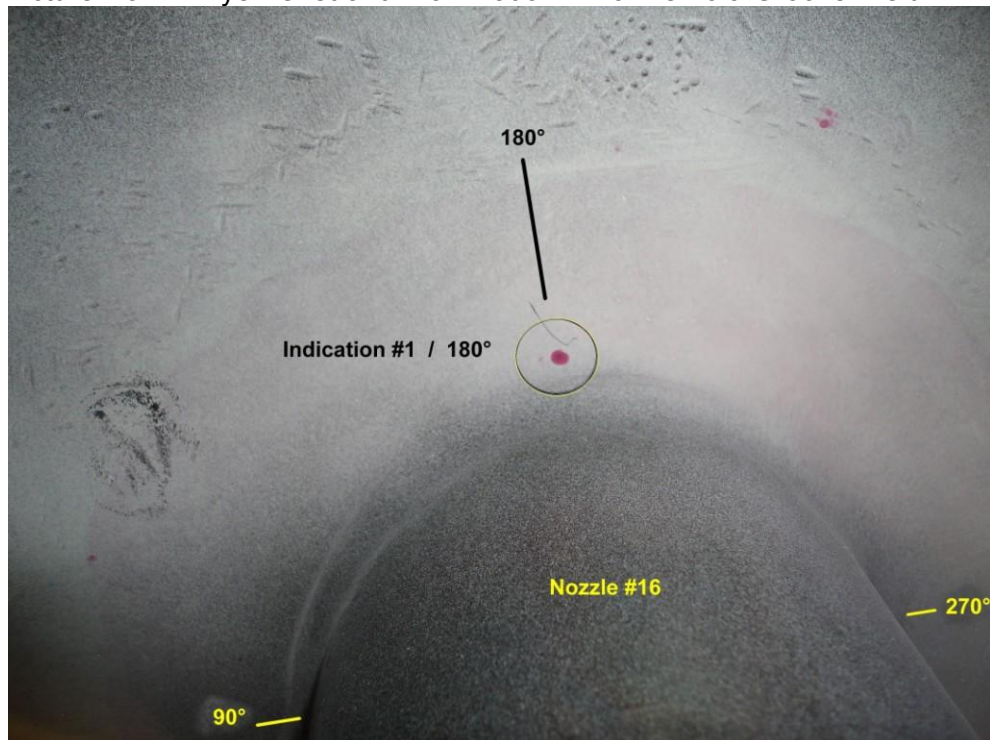
Picture No. 4 - Dye Penetrant Examination – Nozzle 16 J-Groove Weld

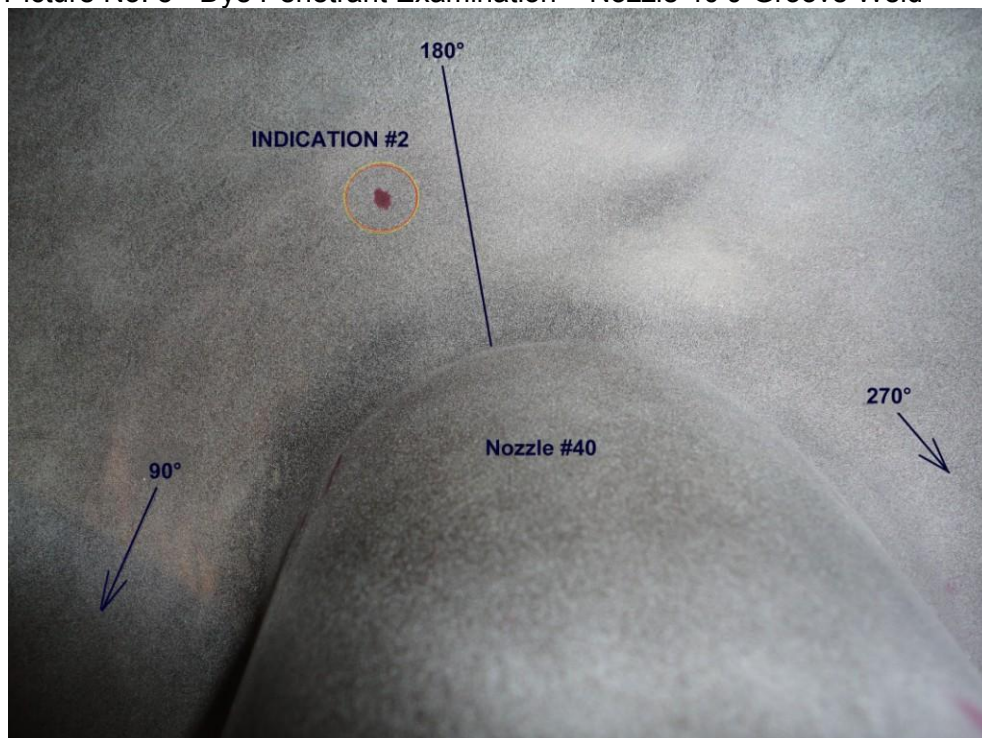
Picture No. 5 - Dye Penetrant Examination – Nozzle 40 J-Groove Weld

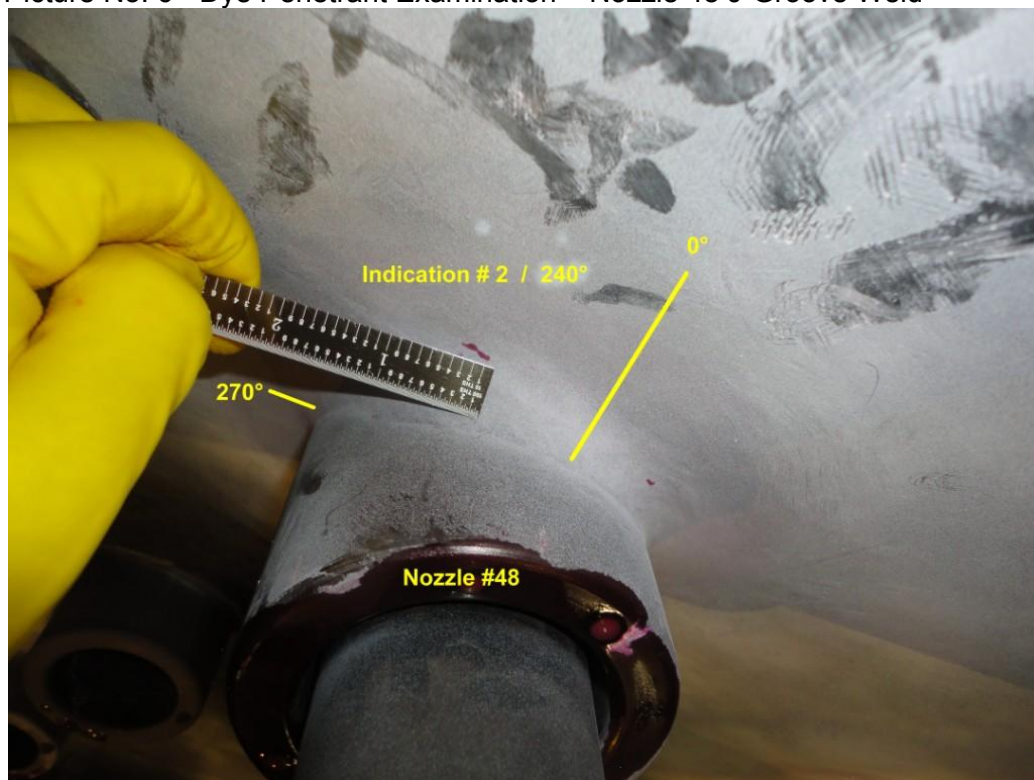
Picture No. 6 - Dye Penetrant Examination – Nozzle 48 J-Groove Weld

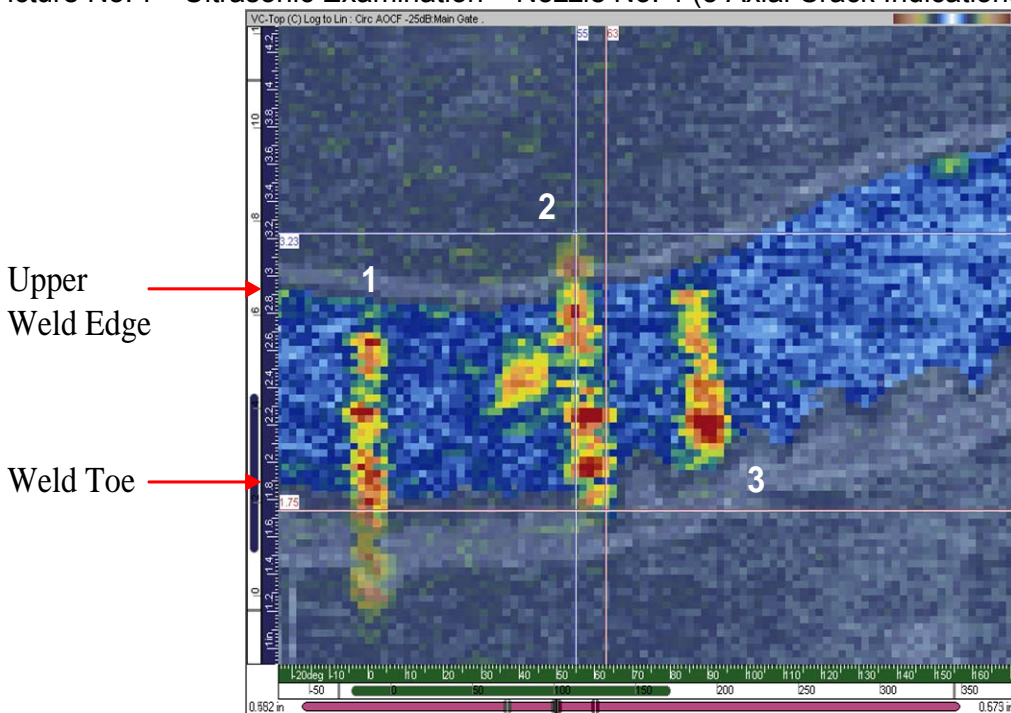
The team concluded that the flaws identified during the current outage were not pre-existing, with the exception of CRDM nozzle Nos. 4 and 64. For nozzle No. 4, indication No. 2 identified during the 2010 UT examination could have propagated from an original construction weld indication identified during the 2002 preservice UT examination. At CRDM nozzle No. 64, a J-groove weld indication was identified during a PT examination at the same location as an original fabrication weld repair. Therefore, this flaw could possibly have propagated from this original fabrication weld repair. The team reviewed the RVCH construction NDE records and confirmed that both nozzle Nos. 4 and 64 had met the construction Code acceptance criteria prior to placing the head in service. The team's comparison of NDE results is recorded in Attachment 3 to this report.

Picture No. 7 - Ultrasonic Examination – Nozzle No. 4 (3 Axial Crack Indications)

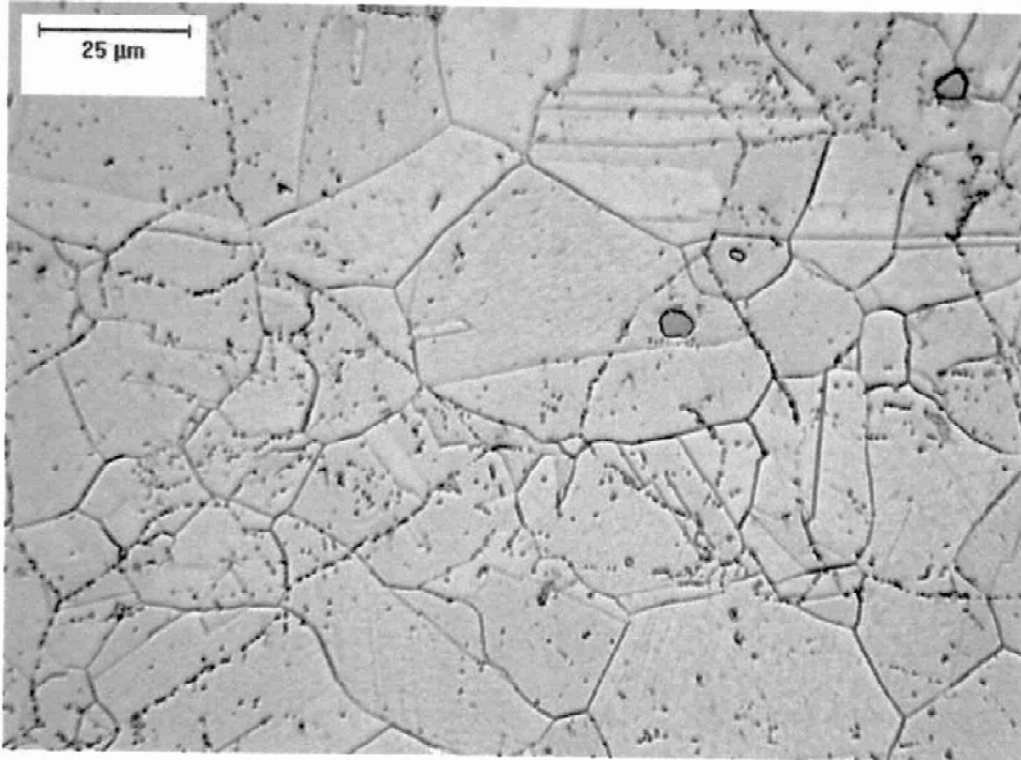
The licensee-identified that the causal factors responsible for the early onset of this PWSCC were, a higher RVCH operating temperature than previously assumed, and a random carbide distribution in the Alloy 600 CRDM nozzle material that resulted in a microstructure more susceptible to PWSCC.

Picture No. 11 – Random Carbide Distribution - Material Heat No. M7929
